## **R22 & R44 SAFETY ALERT**

Issued: 04 January 2007      Revised: 16 March 2007

### **MAIN ROTOR BLADE SKIN DEBONDING**

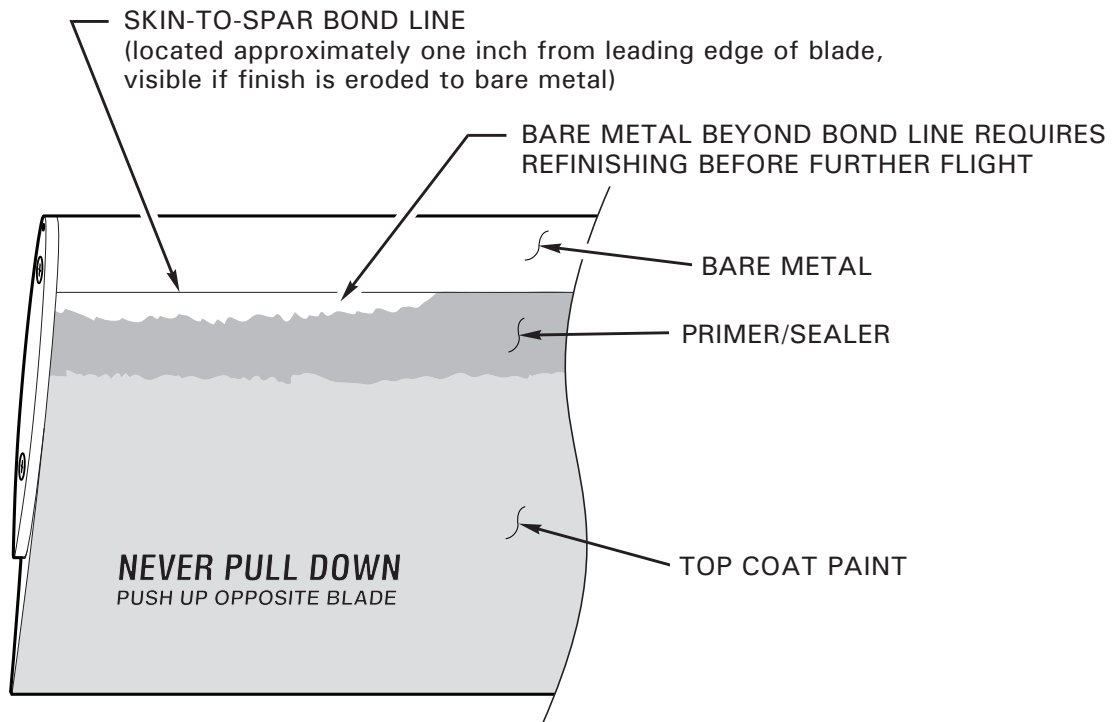
RHC has received additional recent reports of main rotor blade skins beginning to debond (separate) at the skin-to-spar bond line on the lower surface near the blade tip. Debonding can occur when the leading edge of the skin is exposed due to erosion of the blade finish at the bond line (seam between leading edge of the skin and spar).

**MAIN ROTOR BLADE LOWER SURFACE**  
(Shown with excessive erosion of finish.)

See figure below. During each daily preflight, visually check blade finish along lower surface bond line. If any bare metal is exposed beyond bond line, have blade refinished per R22 Service Letter SL-56 or R44 Service Letter SL-32 by a qualified mechanic before further flight.
