R44 SAFETY ALERT

Issued: 7 June 2007

AVOID FLYING OUT OF TRIM

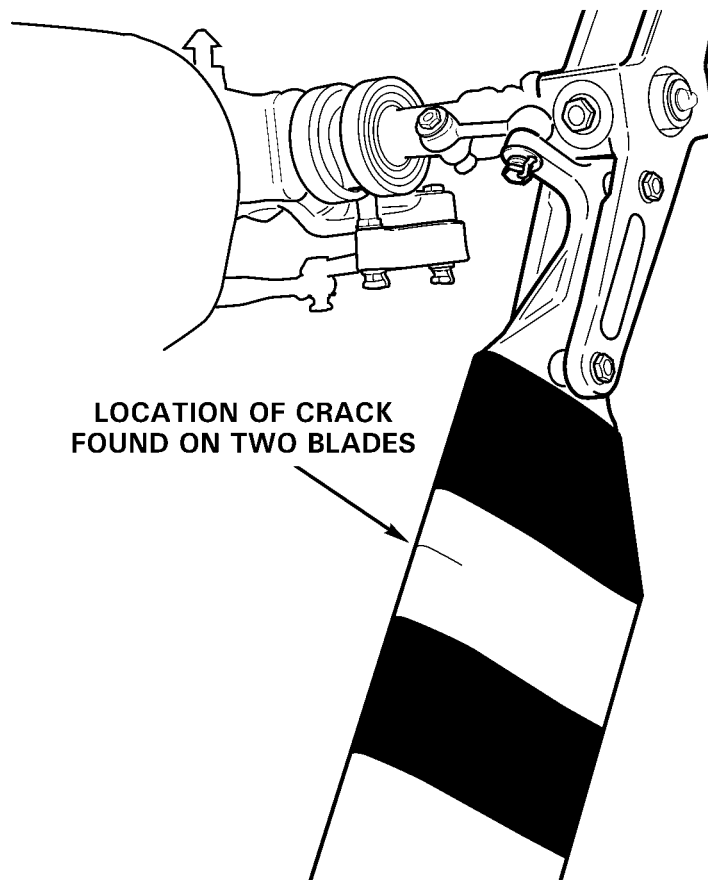
RHC has received two R44 tail rotor blades with fatigue cracks at the leading edge in the most inboard white paint stripe (see figure below). The cracked blades were from police helicopters that frequently performed orbits with a nose-left yaw (using additional left pedal input). Using left pedal to force the helicopter to fly out of trim can cause high fatigue stresses in the blades.

**TO PREVENT A CATASTROPHIC TAIL ROTOR BLADE FAILURE,
AVOID FLYING OUT OF TRIM.**

During each preflight, inspect leading edges of tail rotor blades for cracks. Wipe blades clean if necessary to make sure potential cracks are visible.
