**R44 SERVICE BULLETIN SB-72**

**SUBJECT:** Main Rotor Blade Bond Inspection

**ROTORCRAFT AFFECTED:** R44 helicopters with C016-2 main rotor blades, and R44 II helicopters with C016-5 main rotor blades.

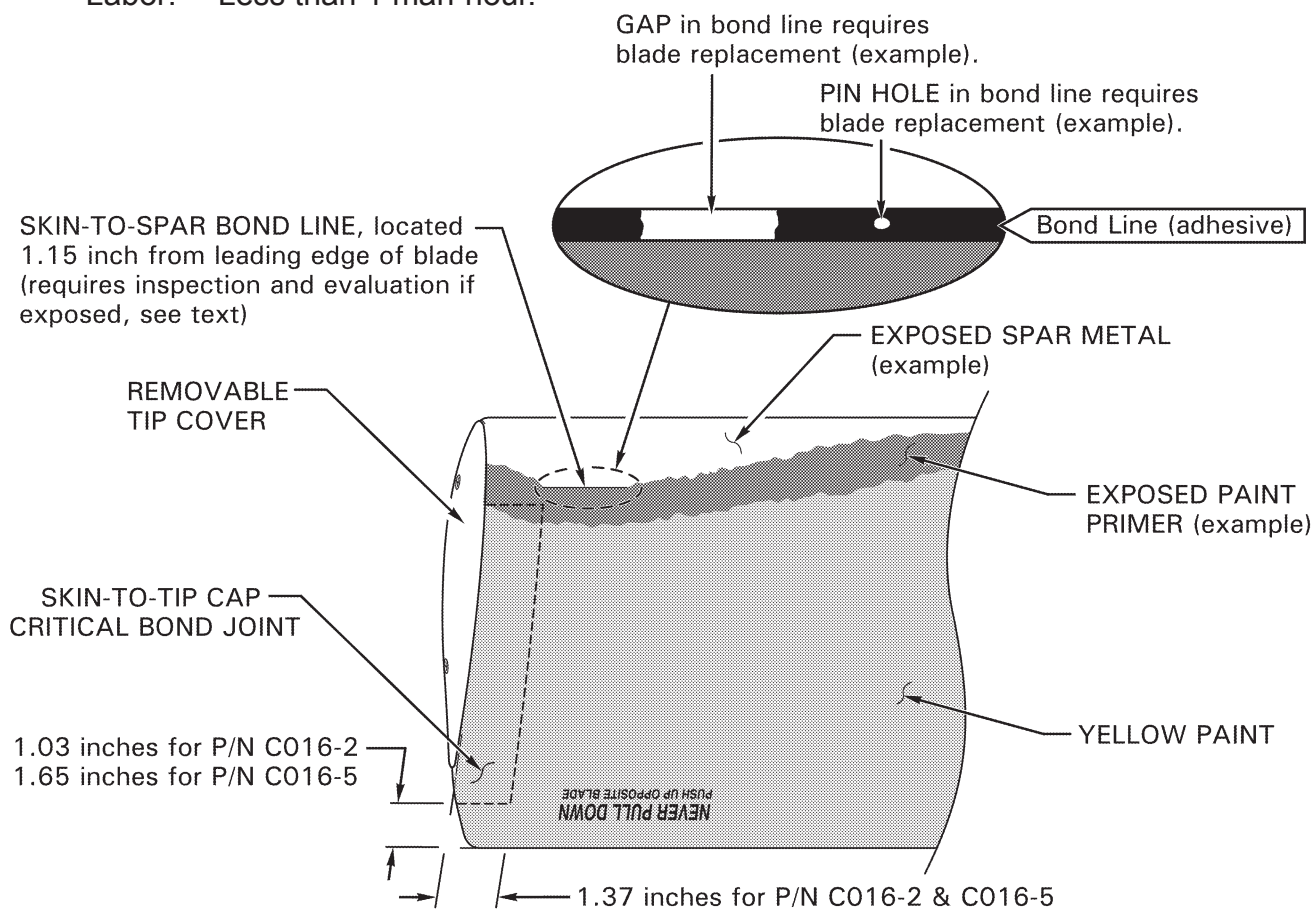
**BACKGROUND:** Debonding of rotor blade skins can occur when the bond line is exposed due to erosion of the blade finish, or when corrosion occurs on the internal aluminum tip cap. Proper inspection and protection (refinishing) of bonded areas is required. Debonding resulting from improper inspection and maintenance could cause a catastrophic accident.

**FIGURE 1 TIP AREA AND LOWER SURFACE**  
(Example, Blade with Excessive Paint Erosion)

1. Refer to Figures 1 and 2. Remove both main rotor blade tip covers and clean the blades.
2. Using 10x magnification, visually inspect uncovered skin-to-tip cap bond joints. Using a 1965-or-later United States quarter-dollar coin, tap test skin-to-tip cap bond joints on both upper and lower surfaces. If corrosion, separation, or voids are detected, blade is unairworthy. Tap test tutorial video is available at: [www.robinsonheli.com/support.htm](http://www.robinsonheli.com/support.htm).
3. Using 10x magnification, visually inspect any exposed skin-to-spar bond line for gaps (empty space between skin and spar). Blade is unairworthy if any gap, including "pin hole(s)", is detected in the bond line.
4. Refer to Figure 2. Mark outboard 135 inches of blade lower surface as shown to identify skin-to-spar bond joint area.

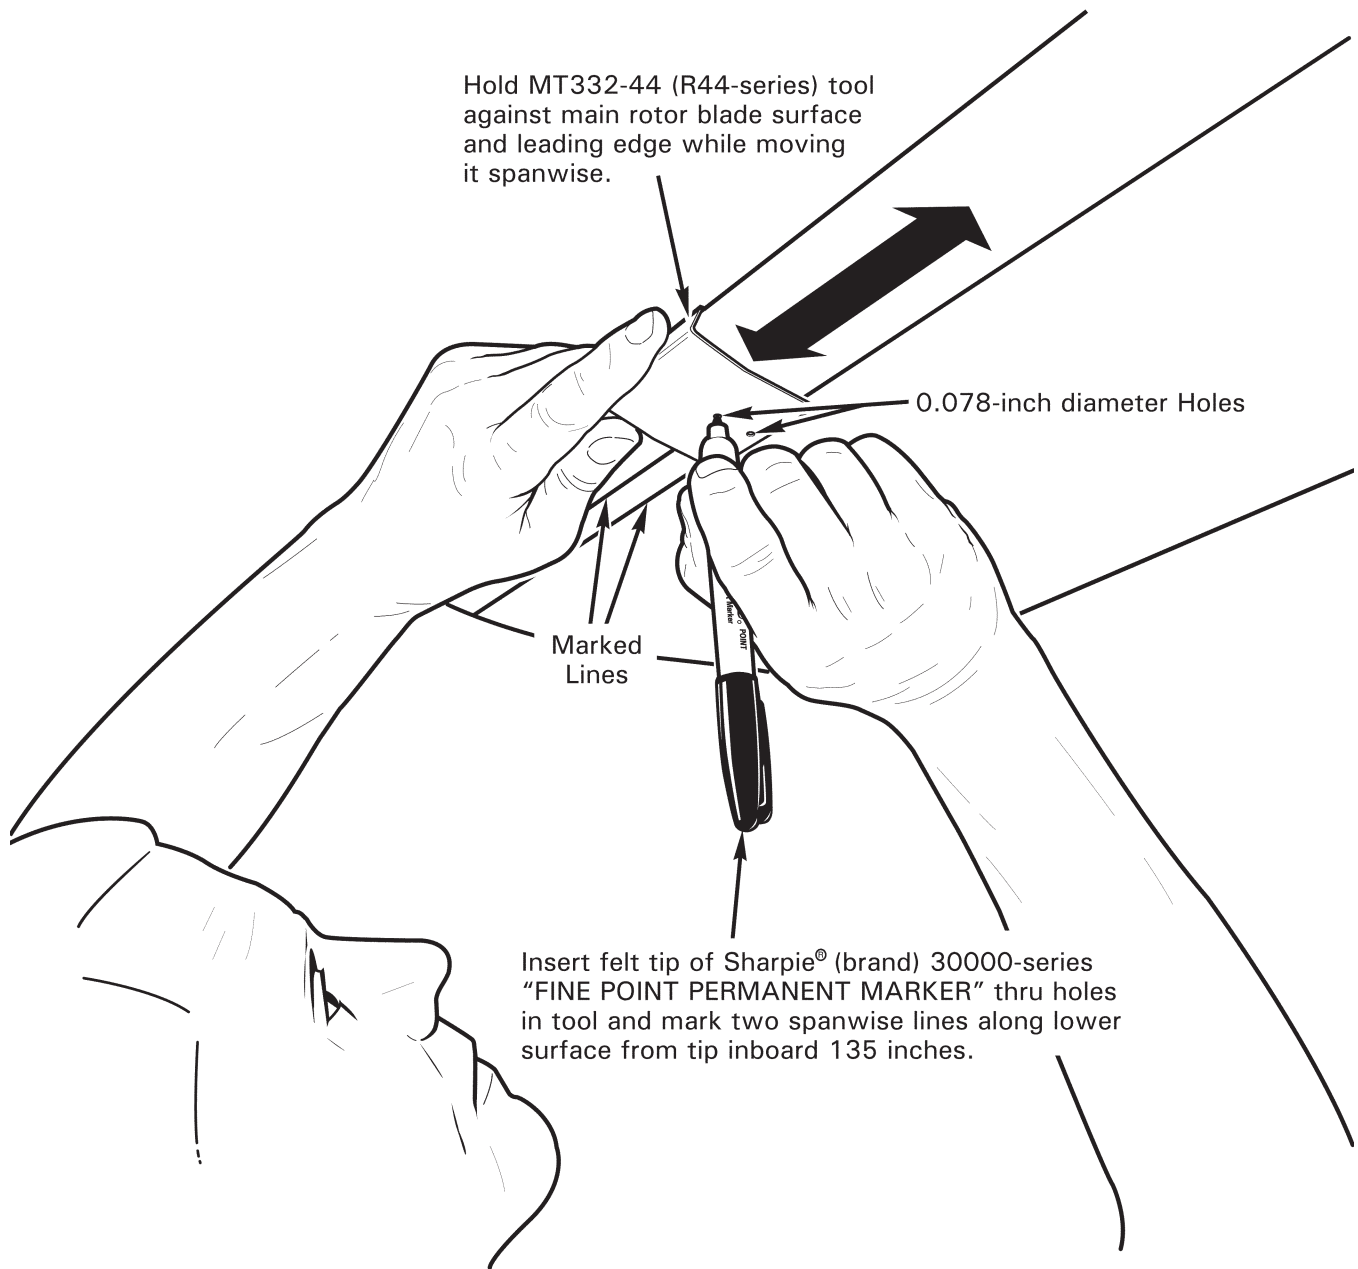
FIGURE 2 MARKING LOWER SKIN-TO-SPAR BOND JOINT AREA

5. Verify no visible dents within the bond joint area. Blade is unairworthy if bond joint area is dented.
6. Tap test the lower skin-to-spar bond joint and verify no voids exist. Blade is unairworthy if a void is detected.
7. Refinish all exposed bare metal per R44 SL-32B.
8. Install blade tip covers, ensuring cover edges are flush with blade profile.
9. Make appropriate maintenance record entries.
