RHC SAFETY ALERT

Issued: 04 January 2007

MAIN ROTOR BLADE SKIN DEBONDING

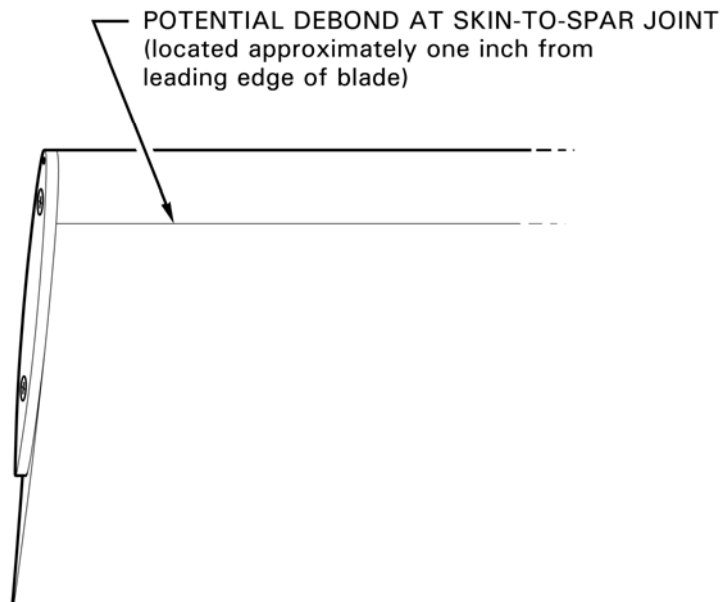
RHC has received reports of main rotor blade skins beginning to debond (separate) at the skin-to-spar joint on the lower surface near the blade tip (see figure). All RHC main rotor blades (R22, R44, and R44 II) are of similar construction and may be affected. Erosion, corrosion, or other damage may increase probability of debonding. Careful visual inspection of this area during the daily preflight will provide early detection and prevent a catastrophic failure. In flight, unusual noise (whistling or howling) or vibration from the rotor system may provide early indication of a skin debond.

MAIN ROTOR BLADE LOWER SURFACE
(Typical view. R44 II blades have
rounded tips.)

During daily preflight inspection, carefully visually inspect skin-to-spar joint area, particularly within 10 inches of blade tip (a stepladder may be necessary). If any area of skin is not flush with spar, the blade is unairworthy. On blades with paint at skin-to-spar joint, a crack in the paint may indicate a debond. If any indication of debond is detected, ground aircraft pending a more detailed "tap test" inspection by a qualified mechanic.

If unusual rotor system noise or vibration is detected in flight, land immediately and have blades inspected by a qualified mechanic.
